**AGENDA  
CITY COUNCIL  
WORK SESSION  
CITY OF WYOMING, MINNESOTA  
SEPTEMBER 2, 2025  
5:30 PM**

## Property Condition Assessment Report

**Re: Property Condition Assessment Report**  
**Wyoming Business Center**  
**26263 Forest Boulevard**  
**Wyoming, MN 55092**  
**Nova Project: W25-6583**

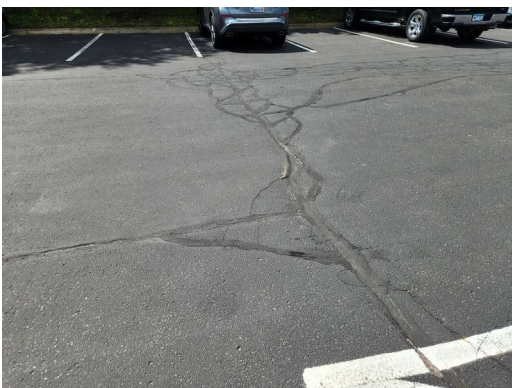
Nova identified several areas of damaged asphalt pavement in the drive lanes of the parking areas, consisting of large cracks and alligatoring. In order to prevent further deterioration and mitigate tripping hazards, these areas should be repaired immediately. Periodic seal coating and restriping is also anticipated during the reserve term.

11. Asphalt temp repairs

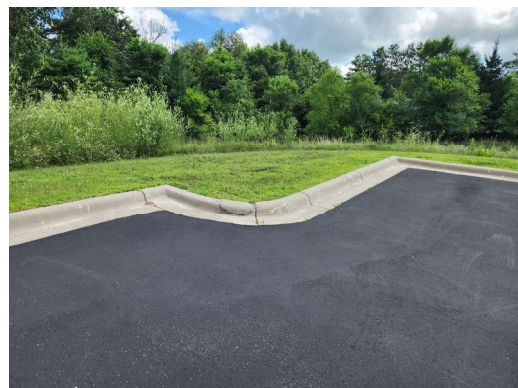
An area of concrete curb damage from snow plowing was noted at the northeast corner of the parking lot and should be addressed as part of routine maintenance.

12. Plow damage

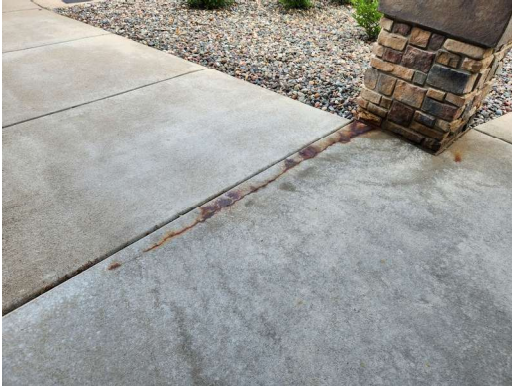
The sidewalks are generally in good to fair condition. There are limited locations of tripping hazards observed near the parking area in front of the eye care clinic. Another concrete crack, exhibiting excessive rust staining, was observed at the northeast main building entrance. These areas should be repaired immediately.

13. Cracking and stained concrete

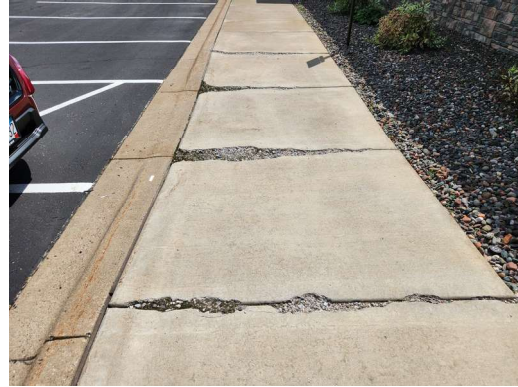
14. Crumbling concrete

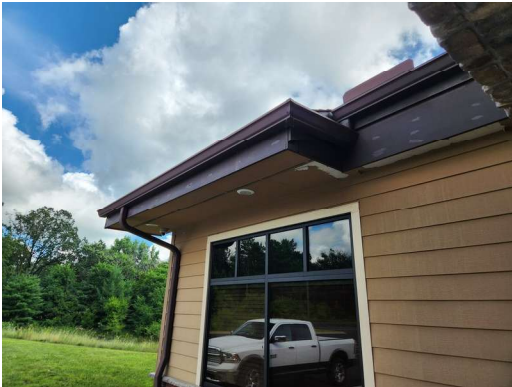
The exterior facades are in good condition. Repainting and recaulking will be required during the reserve term.

15. Peeling paint under eave

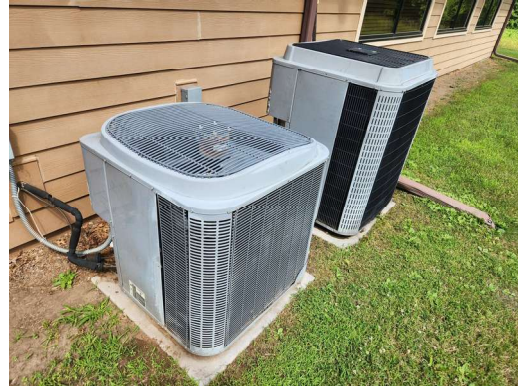
The split systems are in good condition, relative to their individual age. Replacement of four condensers is anticipated during the reserve term.

20. Air conditioning units

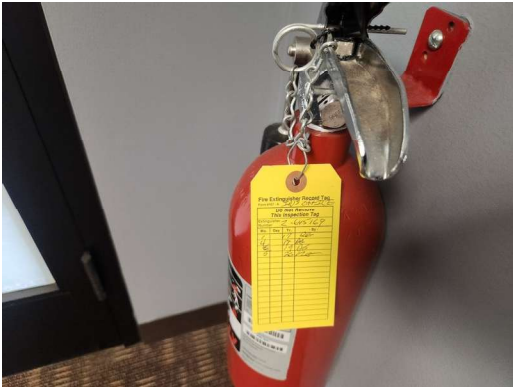
33. Fire extinguisher (expired)

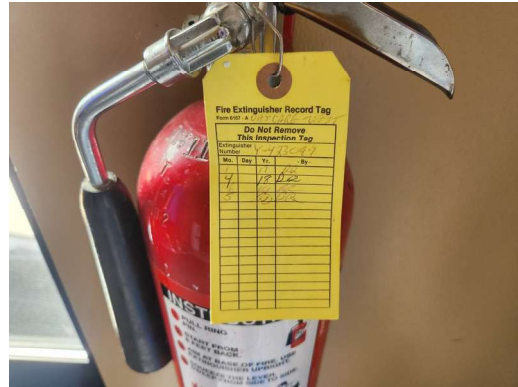
34. Fire extinguisher (expired)
